Repairing broken rear window defroster tabs and missing defroster pulled off by tab.

Repair missing defroster pulled off by tab

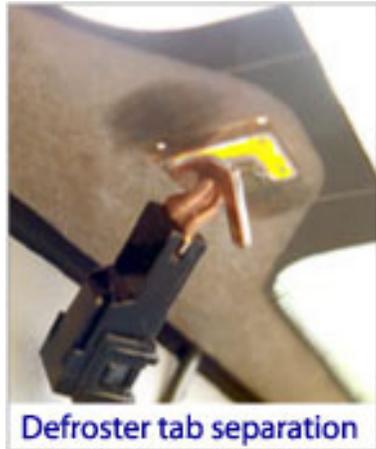
When a metal tab separates from the defroster it can pull away some of the defroster coating from the glass. Sometimes the tab breaks leaving the base of the tab still attached to the defroster.

Defroster tab separation

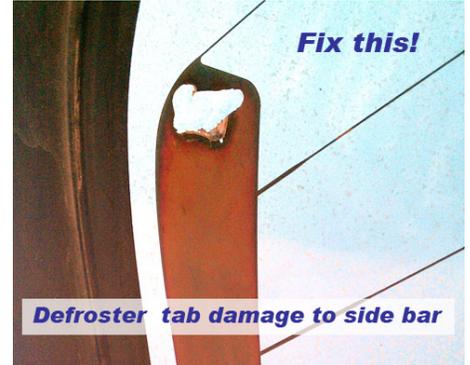
Defroster tab damage to side bar

Badly damaged defroster occurred when the tab pulled some of the defroster material away from the glass.

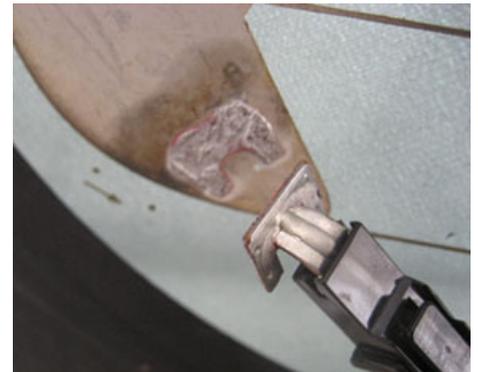
Damaged defroster pad

The first step is to create a small pad of conductive coating over the damaged area on the defroster.

First clean up and smooth the damaged area. A screw driver can be used to scrape the area and then sandpapered for a relatively smooth surface. The goal is a good conductive bond between the defroster and the replacement tab.

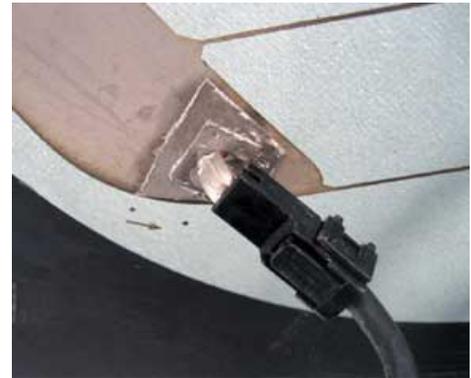
Damage repaired

Make sure the bonding pad is smooth and even and then dip the tab base in the adhesive and position it on top of the bonding area while wet. Be sure to check the orientation of the tab so it can be re-reconnected to the connector when the time comes.

Next, hold the connector in place (light pressure with screw driver or pliers) and using a hair dryer, heat lamp or other heater warm up the bond site for several minutes until the adhesive starts to lock down. Then keep the area warm (100-130 F) for at least 30 minutes and your back on the road with a working defroster.

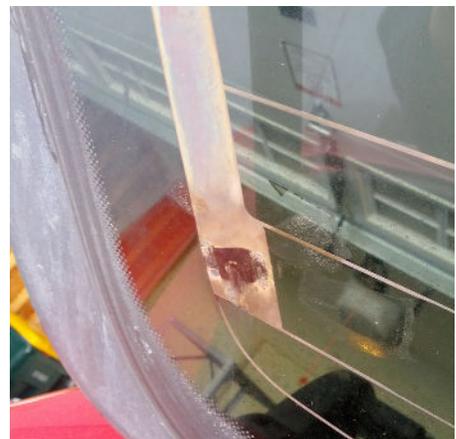
More defroster damage

If the tab base is still on the defroster there are two options. If there is enough defroster material around the tab it is appropriate to bond the new tab to the defroster close by the broken tab base.

The other option is to remove the tab base and bond the replacement tab in its place.

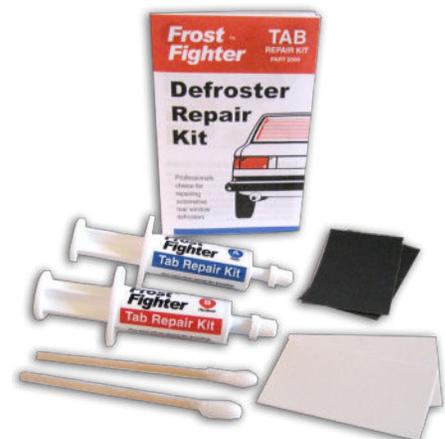
2000 Tab Bonding Kit

The 2000 Tab Bonding kit is a highly conductive two part silver adhesive that cures quickly, bonds aggressively and forms the electrical and structural connection to the defroster in one simple operation.

The adhesive's high silver loading provides maximum electrical conductivity ideal for the high amperage bonds needed in defroster tab repair.
